Concrete Floors in Existing Industrial Buildings...

ASSET OR LIABILITY?®

By **Steven N. Metzger**
President
Metzger/McGuire
Concord, New Hampshire

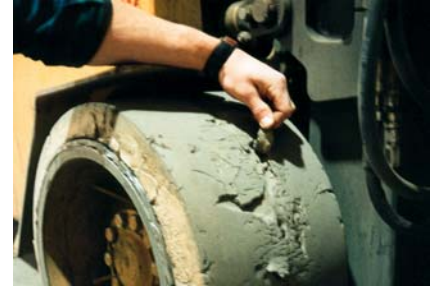
Deteriorated Floors Drain Productivity from Operations and Increase Material Handling Vehicle Maintenance Costs
